System Theoretic Safety Analysis of the Sewol-Ho Ferry
Accident in South Korea

by
Yisug Kwon

Submitted to the System Design and Management Program in
Partial Fulfillment of the Requirements for the Degree of

Massachusetts Institute of Technology

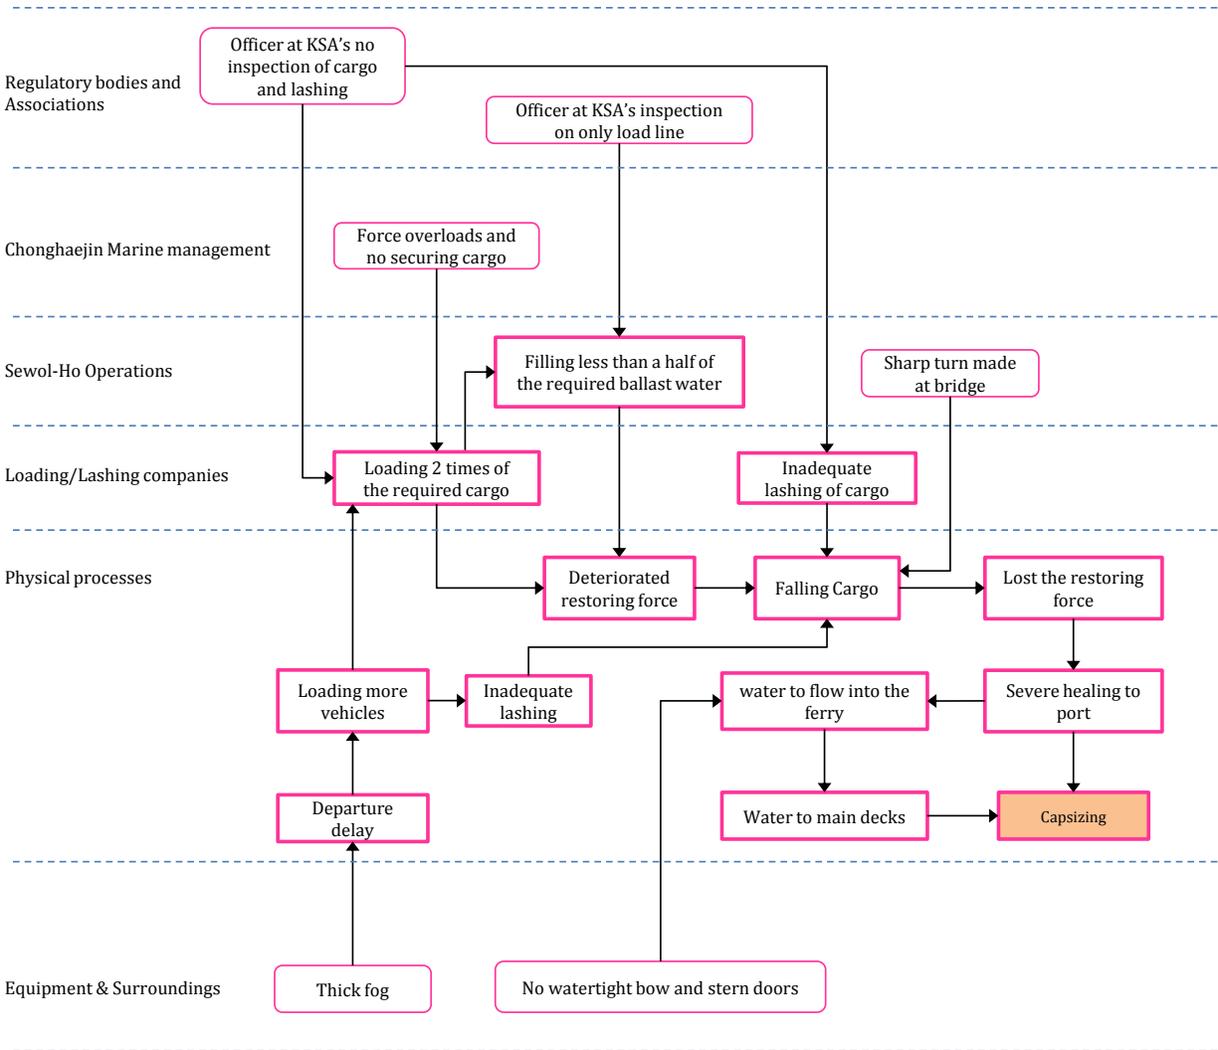
Figure 6 Graphical Summary of Process 1: Safe operations of the ferry

The overall effect of the turning was that the ferry turned about 45 degrees to starboard and then, rotated 22 degrees on the spot for about 20 seconds. The cargo containers falling to one side caused the ferry to lose the restoring force and allowed the ferry to take on water through the bow and stern doors. On 0850, the ferry was listing 30 degrees to port. Around this time, the Chief engineer, Park, Ki-Ho stopped the engines on his own judgment. The Captain who was in his cabin immediately went to the bridge and ordered the second mate, Kim, Young-Ho to turn on the anti-heeling pumps to return the ferry to its upright position, but the pumps were not working. The Captain ordered the Chief engineer to stop the engines, which were in dead slow ahead condition, and the Chief engineer stopped them. On 0852, the Chief engineer ordered, on his own judgment, evacuation of the engine room through a call to the assistant engineer.

Figure 6 shows a graphical summary of the events causing the ferry's capsizing.

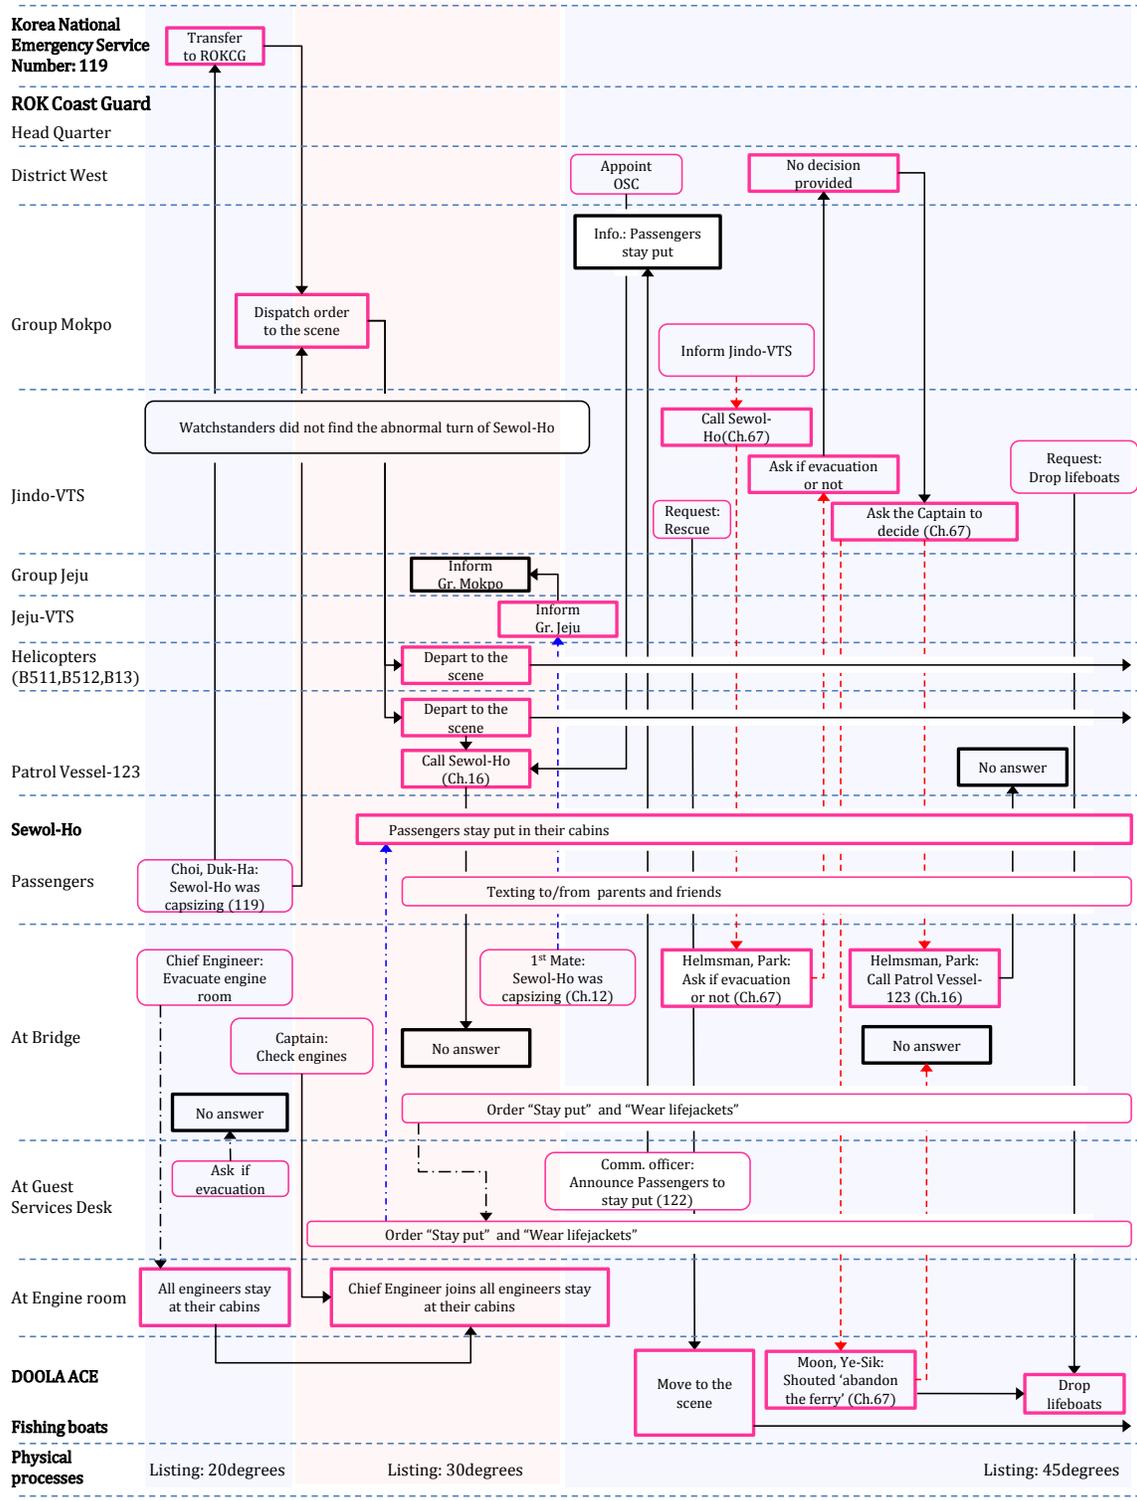
Figure 7 Graphical Summary of Process 2: Rescue operations of people on the distressed ferry (1/2)

Figures 7 and 8 show the graphical summary of the events in the process of Rescue operations of people on the distressed ferry. Indications of elements in the graphics are the following:

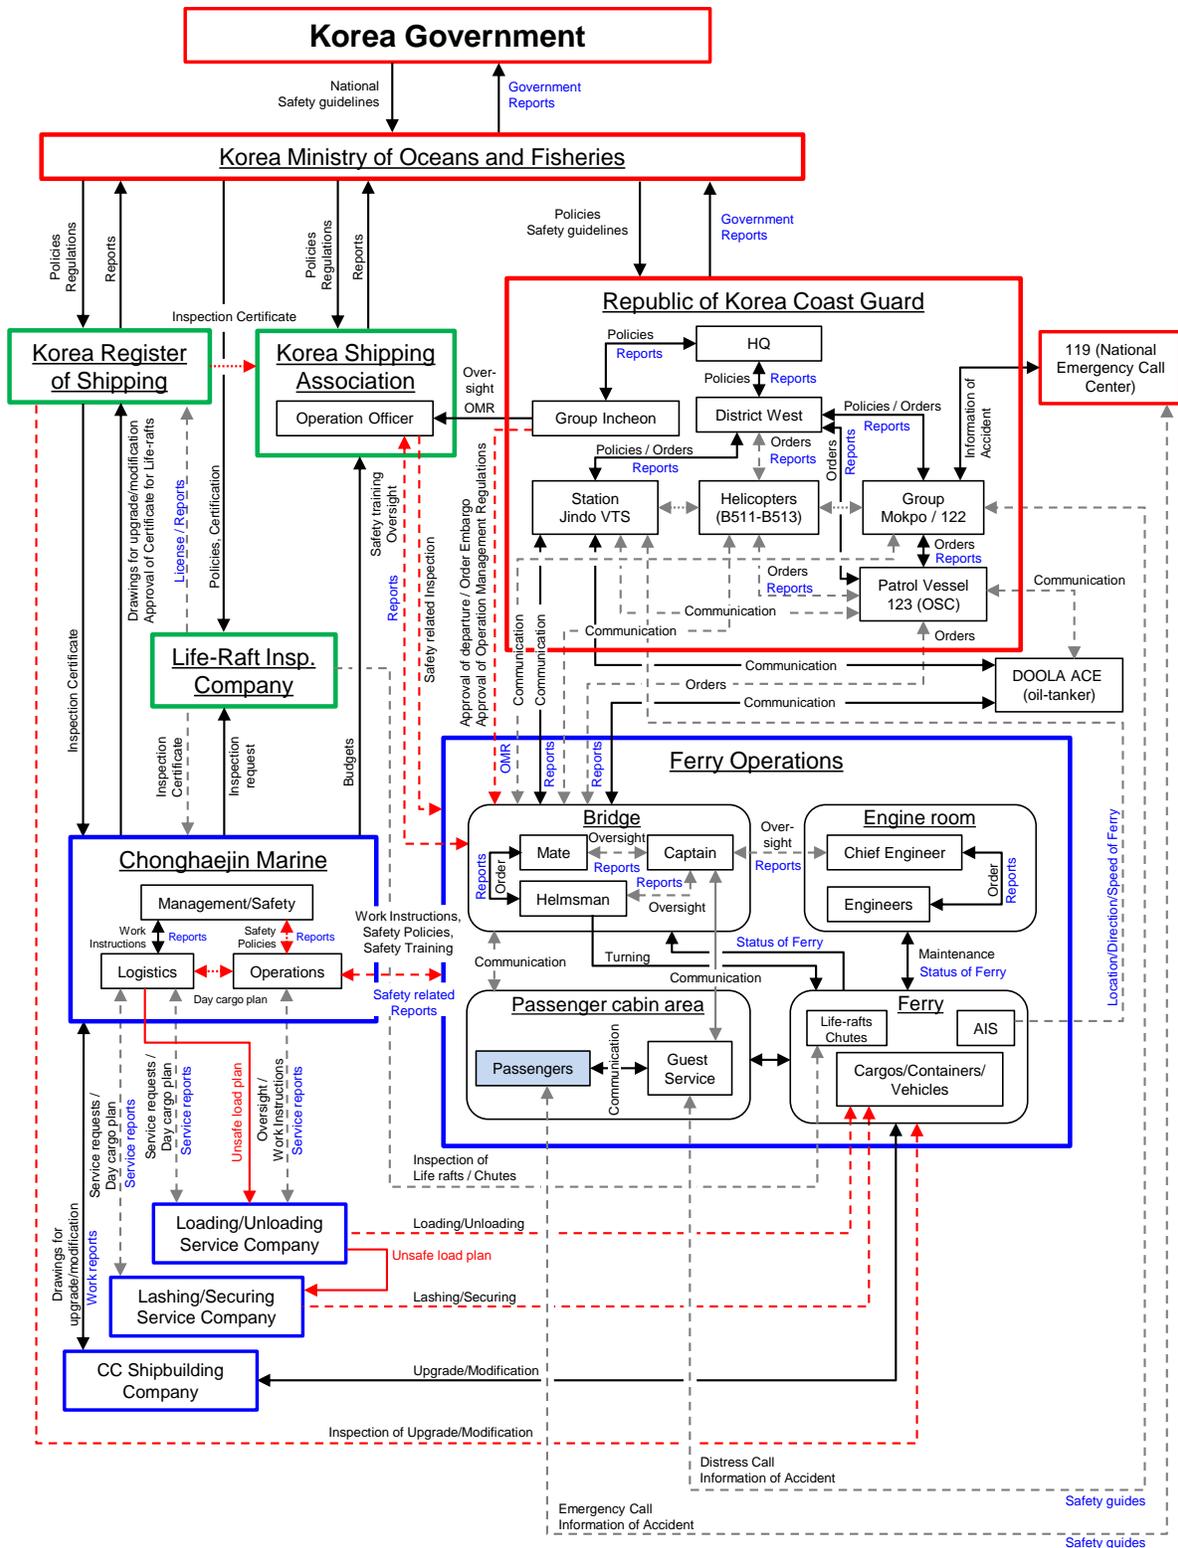
Figure 9 Actual state of Safety Control Structure for Process 1 of “Safe operations of the ferry”

Figure 9 shows the actual state of Safety Control Structure for Process 1 of “Safe operations of the ferry.” The red dot lines in Fig. 9 highlight control actions, controlled variables, measured variables, and control feedback that were either missing or incomplete in the actual Safety Control Structure. And the red line arrows in Fig. 9 highlight the bypassed or unsafe control actions. They should be corrected to prevent the bypassed or unsafe control actions from occurring in future. The bi-directional arrows indicate control actions in black letters to down direction and feedback in blue letters to up direction.

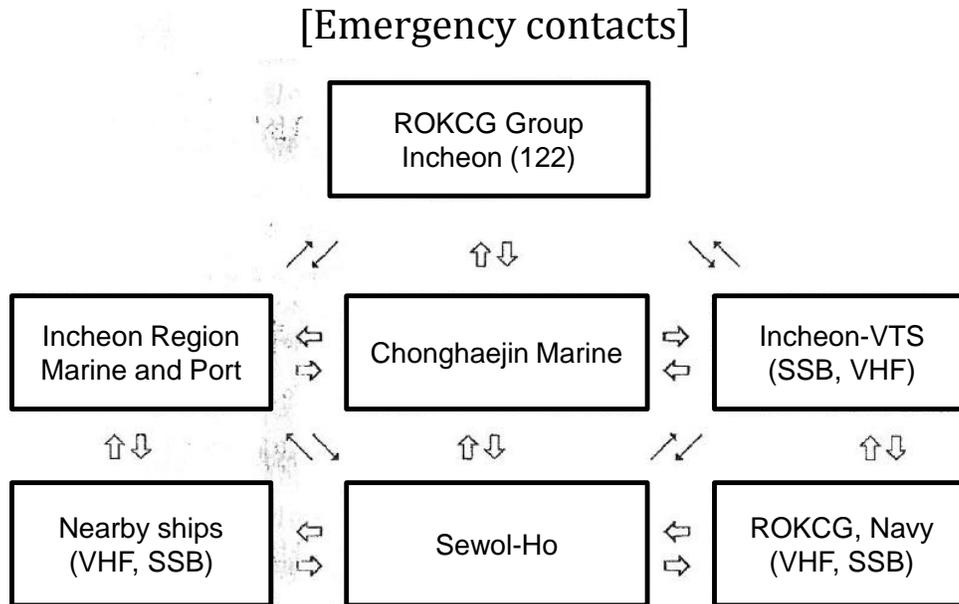
Figure 10 Emergency Contacts of the ferry's Operation Management Regulations Document (OMR)

The Safety Director and Management did not provide and oversee safety training and evacuation drills for the crew other than an exercise practiced for the preparation of ROKCG's safety audit. The budget for safety training per a crew at the company for a year was US \$2, which was used to buy a piece of certificate paper.

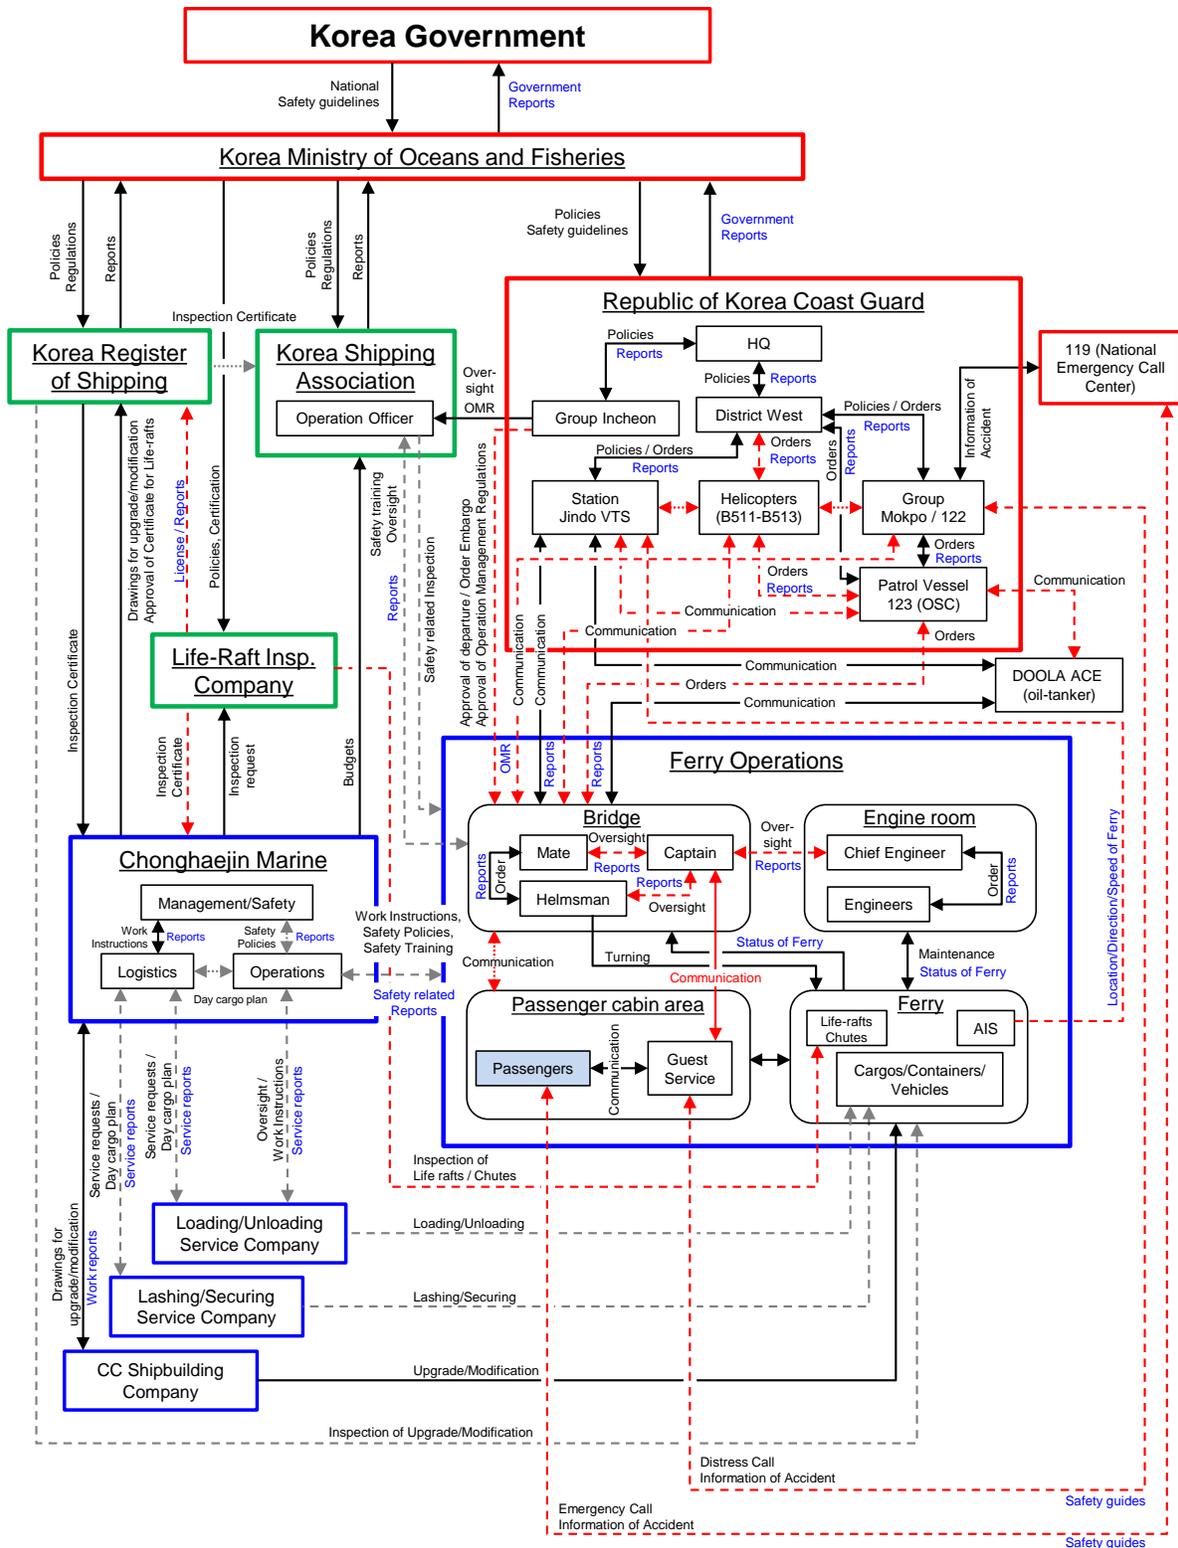
Figure 11 Actual state of Safety Control Structure for Process 2 of “Rescue operations of people on the distressed ferry”

Figure 11 shows the actual state of Safety Control Structure for Process 2 of “Rescue operations of people on the distressed ferry.” The red dot line arrows in Fig. 11 highlight control actions, controlled variables, measured variables, and control feedback that were either missing or incomplete in the actual Safety Control Structure. Moreover, the red line arrow between the Captain and the Customer Service Desk in Fig. 11 highlights the unclear control feedback. They should be corrected to prevent the unsafe control actions and feedback from occurring in future. The bi-directional arrows indicate control actions in black letters to down direction and feedback in blue letters to up direction.
