A System Theoretic Safety Analysis of U.S. Coast Guard Aviation Mishap involving CG-6505

Submitted to the System Design and Management Program
in Partial Fulfillment of the Requirements for the Degree of

Master of Science in Engineering and Management
at the
Massachusetts Institute of Technology

May 2012

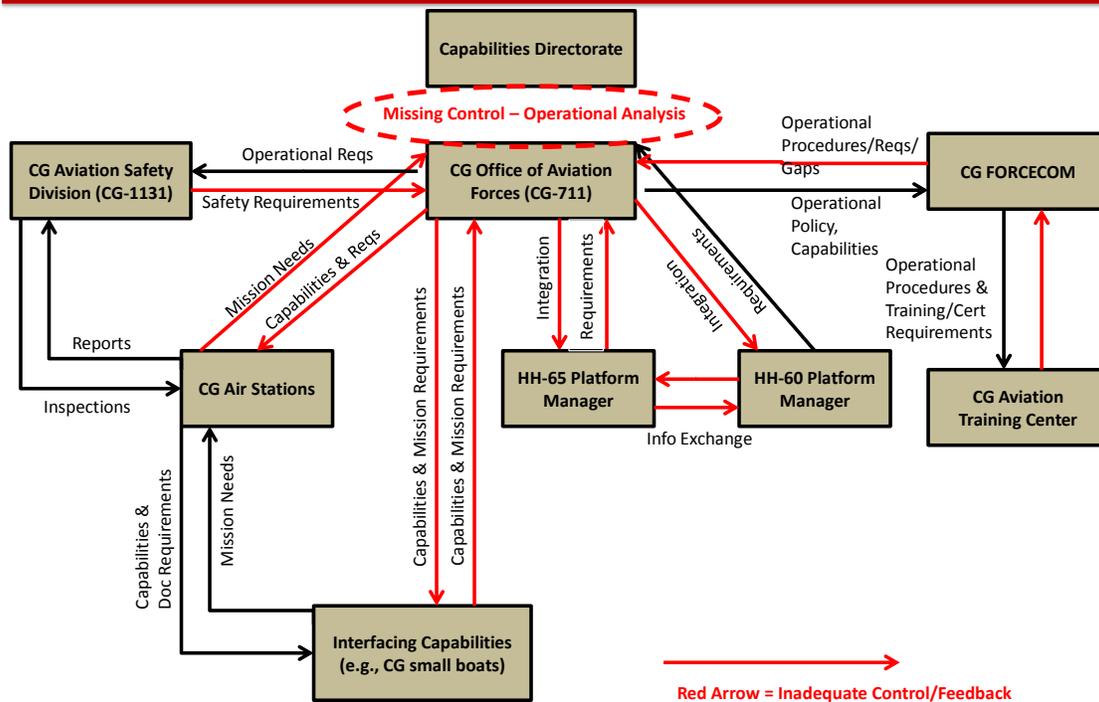
Capabilities Management – Control/Feedback Inadequacies

Inadequate Control/Feedback – Sponsor/User involvement in design/development: Lack of sponsor and user involvement, including like platforms and interfacing capabilities during acquisition and modernization efforts.

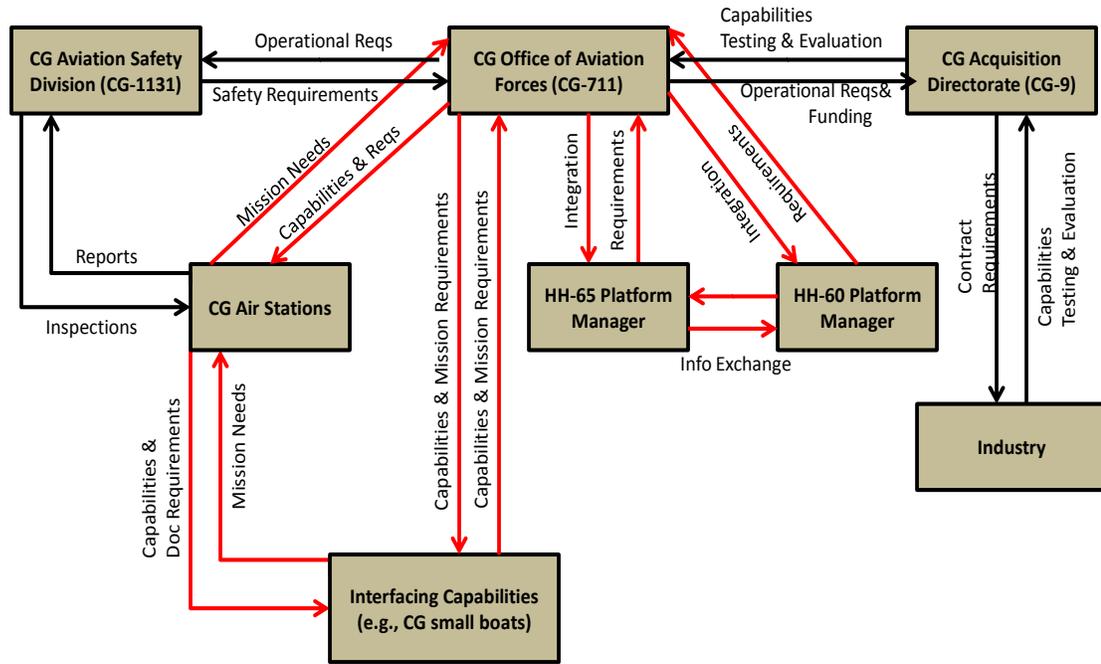
Sponsor/User Involvement in Design & Development – Control/Feedback Inadequacies

Inadequate Control/Feedback – Coast Guard Acquisition Directorate and Industry: Lack of involvement with industry regarding state of the market capabilities and procedures.

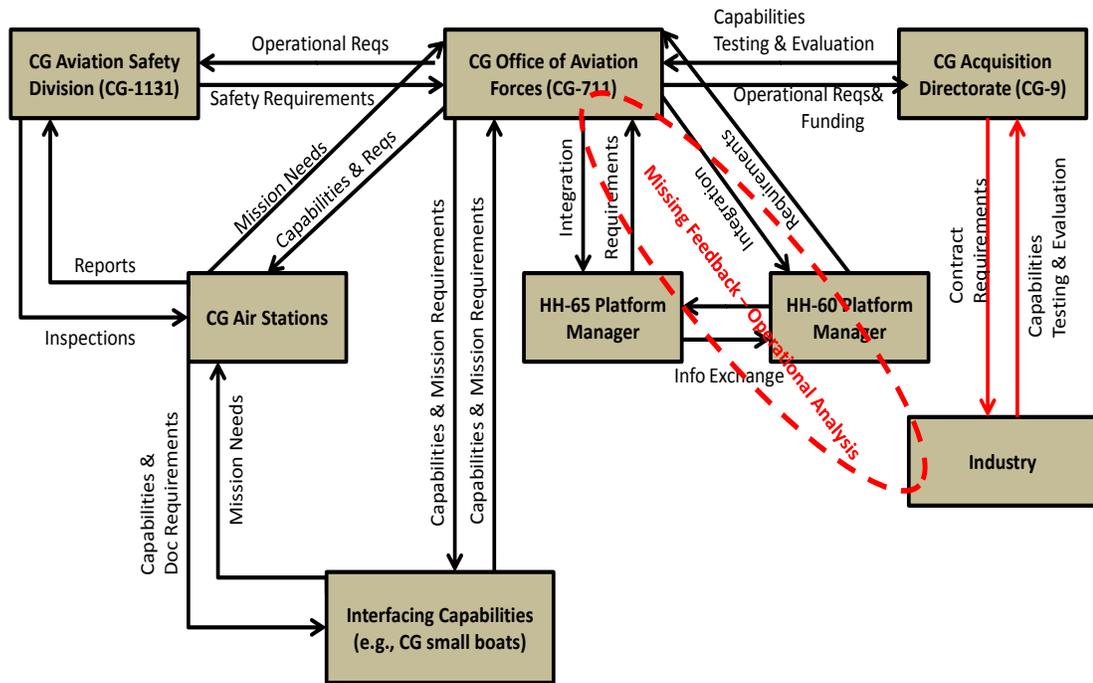
Industry Involvement – Control/Feedback Inadequacies

Inadequate Control/Feedback – Lack of Standardized CRM/ORM Training: Lack of standardized training (observation and reporting) of Crew Resource Management and Operational Risk Management programs through use of multiple training delivery sources, collateral duty program, and limited programmatic guidance. Lack of identifying/cataloguing operational risks and mitigating actions specific to operational procedures/conditions.
