THE UNDERESTIMATED VALUE OF SAFETY IN ACHIEVING ORGANIZATIONAL GOALS: CAST ANALYSIS OF THE MACONDO ACCIDENT

Submitted to the Integrated Design and Management Program
in partial fulfillment of the requirements for the degree of

Master of Science in Engineering and Management

Massachusetts Institute of Technology

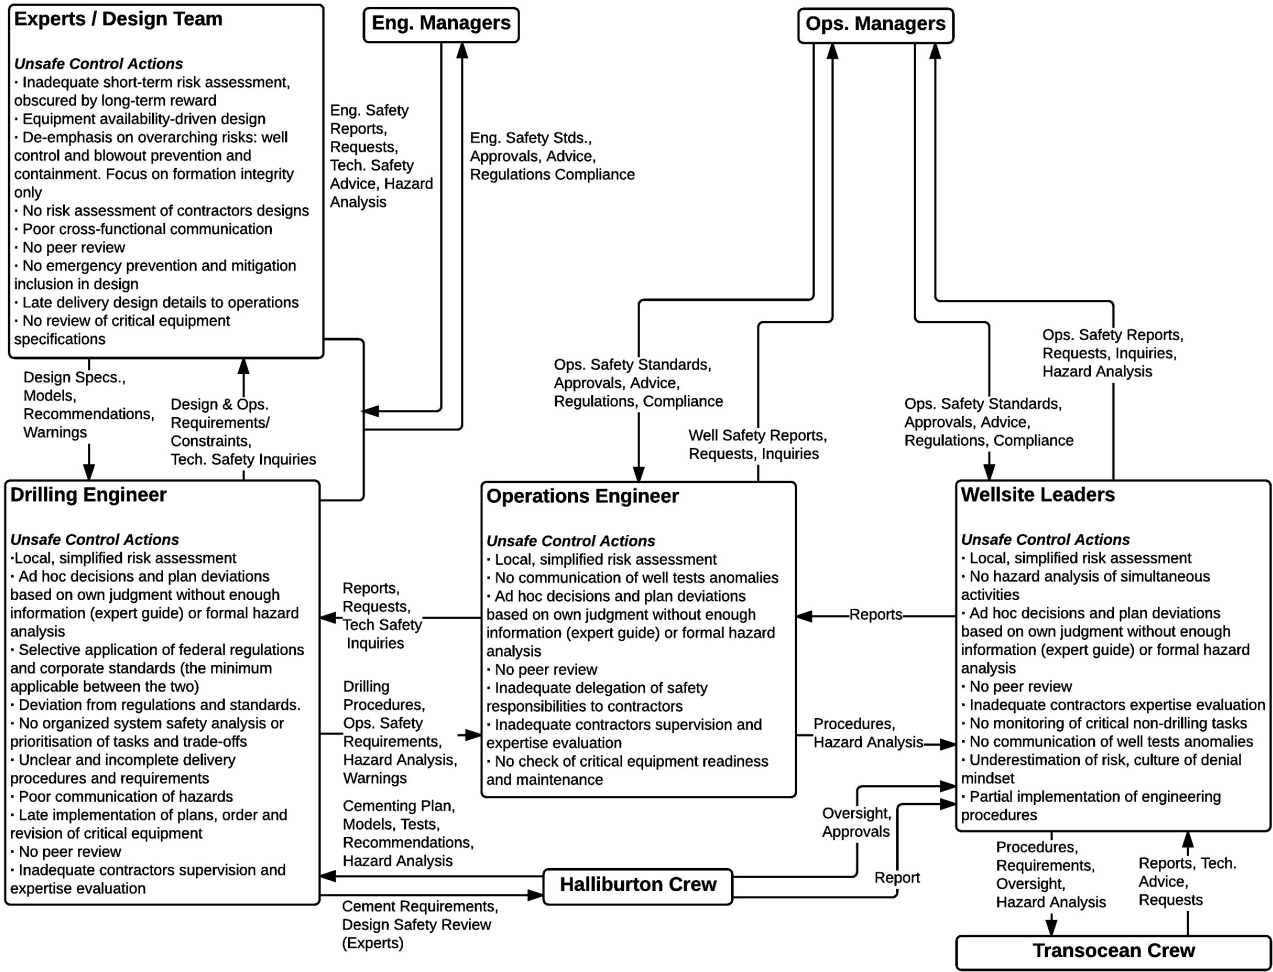
Figure 16. Unsafe control actions of BP Engineers and Well Site Leaders (BP's lowest level of management analyzed).

The most common unsafe control actions in this group include:

- Absence of a system safety assessment plan, combined with underestimation of isolated risks identified by the personnel under their supervision. These unsafe control actions are grounded on poor enforcement of BP's MoC procedures and standards, questionable adherence to regulations and industry practices, lack of dissemination of formal risk analysis tools and minimum use of alternative resources to reinforce well monitoring. For instance, there was no official risk assessment plan for the implementation phase (in particular for non-drilling operations), and there was a deficient audit and maintenance of critical equipment.
- Bias towards cost-driven drilling, in which "the operation" was always priority regardless of safety circumstances.

- Poor understanding of their own safety responsibilities and those of their personnel under supervision, which generated confusion and resulted in tensions within the team. There was no clear and timely dissemination of BP's new and improved risk analysis procedures, investigation of incidents, nor team collaboration and peer review schemes.
- Inadequate personnel assignment and contractors supervision. There was not an effective skill-proficiency evaluation that would ensure that the human controller was prepared for his or her technical and safety role. Similarly, there was no policy to support the team on the rig using alternative procedures such as monitoring the well in real time from shore.

The rationale behind these unsafe control actions is based on a strong believe that faster drilling is better, which can be true for flawless, completely safe projects with cost-reduction objectives.

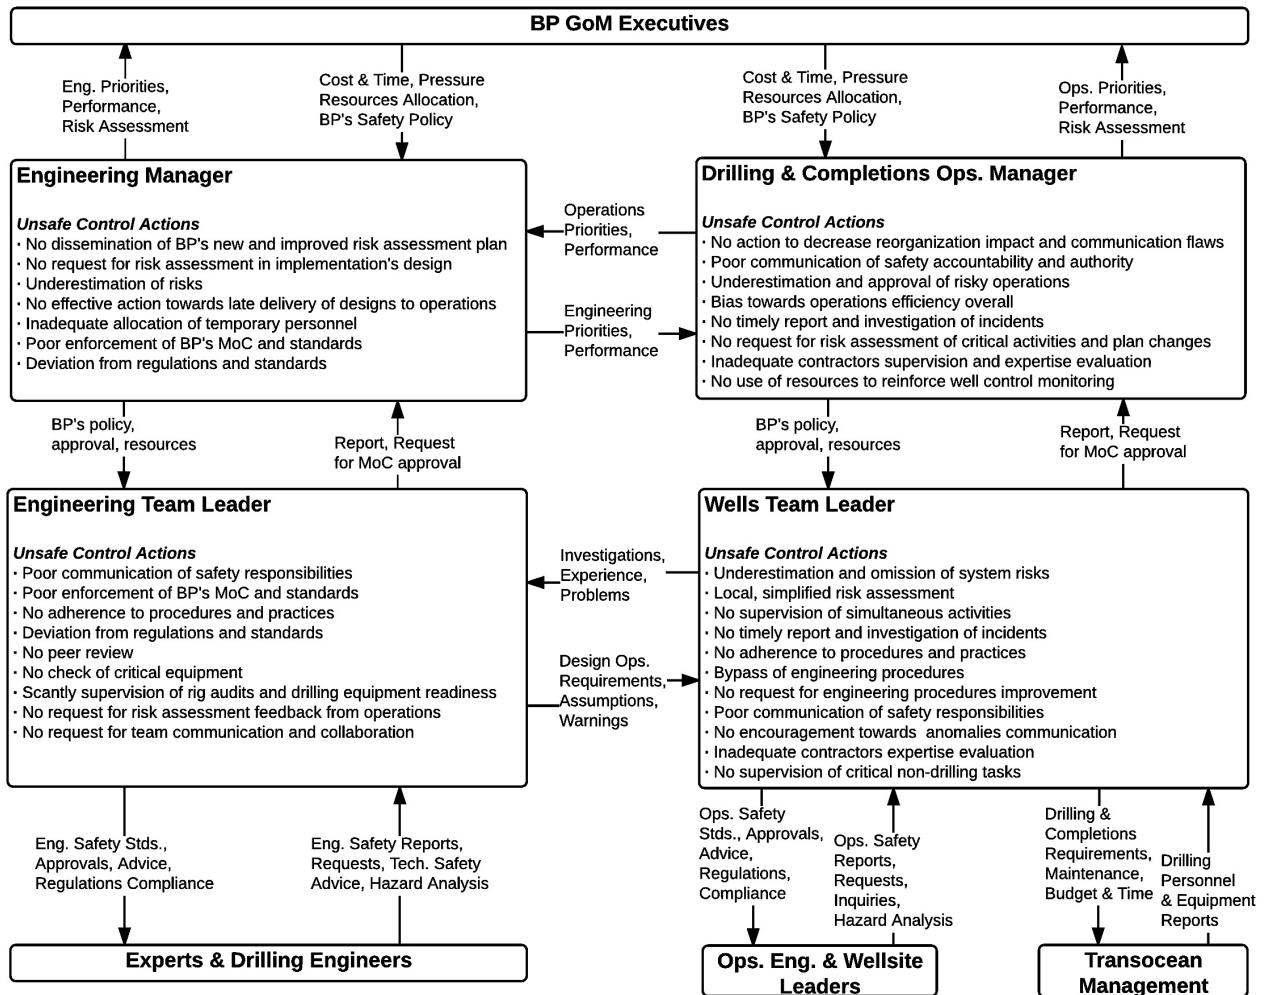
Figure 17. Unsafe control actions of BP Managers and Team Leaders (BP's highest level of management analyzed).

Moreover, managers at this level also assumed that the personnel and the equipment were operating as per regulatory and corporate standards, and that BP's reorganization had not changed anything.

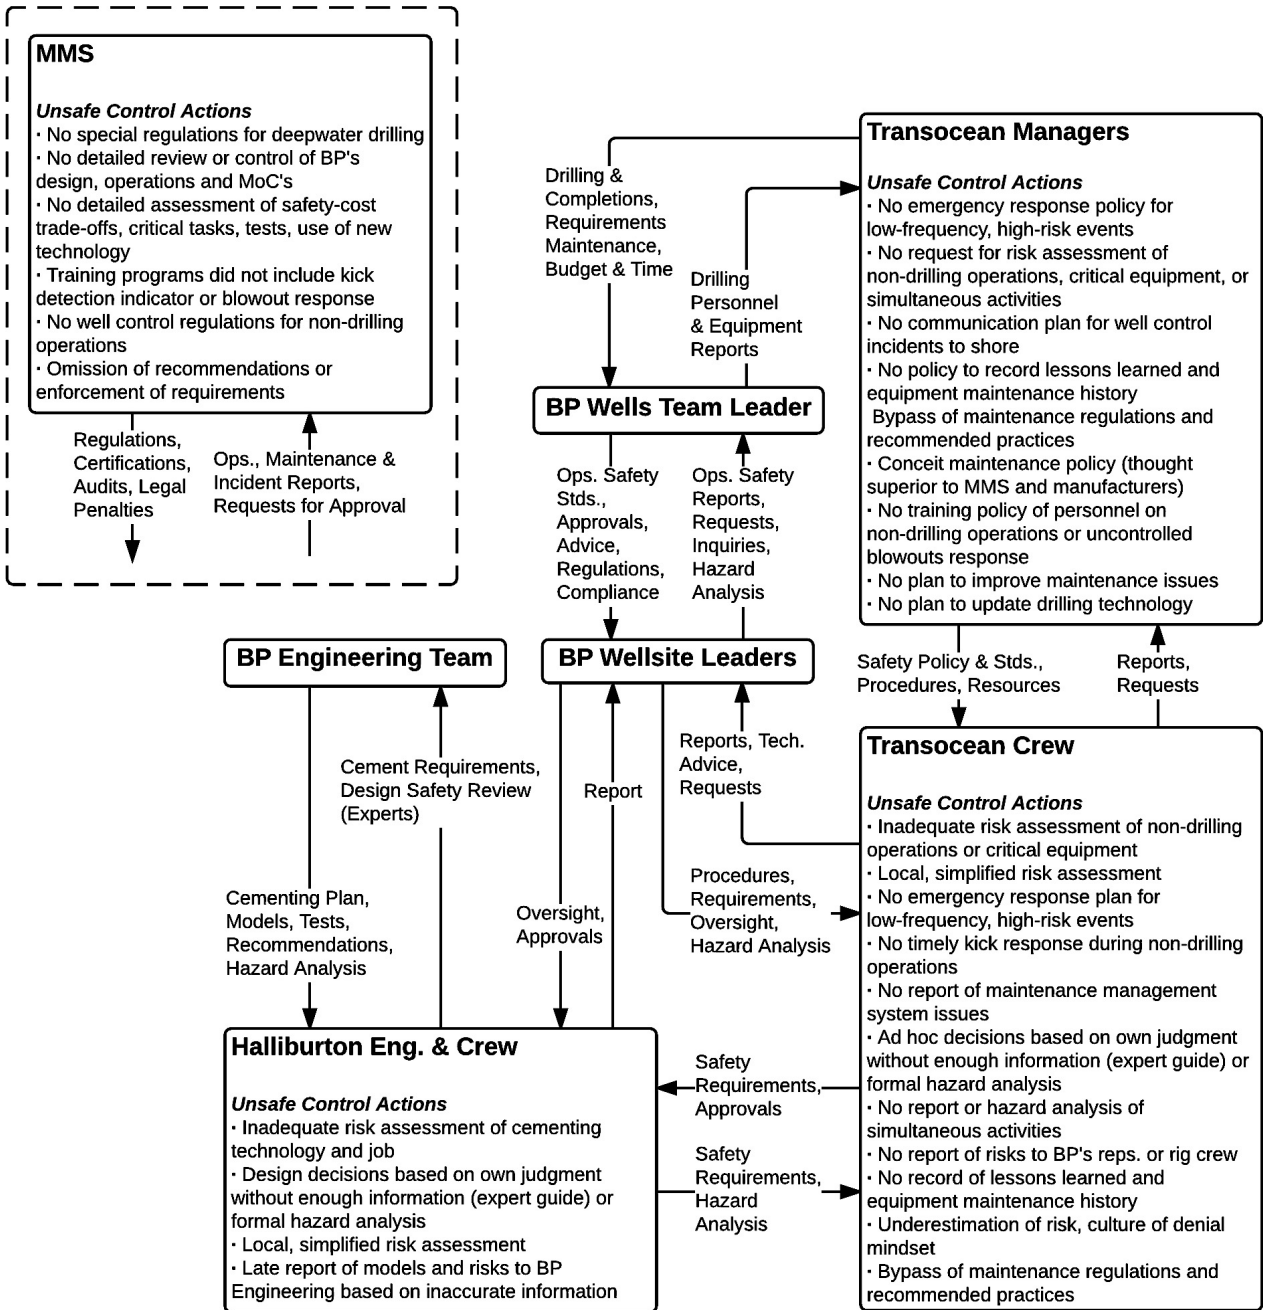
Figure 18. Unsafe control actions of contractors and regulators (MMS).

Furthermore, Transocean's Managers believed that their experience-based training and condition-based maintenance was superior to industry practices and regulations. They supported these claims with their outstanding performance and personal safety records that did not reflect incomplete maintenance registers, poor communication of lessons learned across the company, and uneven automation efforts.

For example, while the platform had state of the art geo-location technology, the drilling software and monitoring system was outdated, but since both were “working” as per their standards, the disparity and need for improvement was not visible to them.

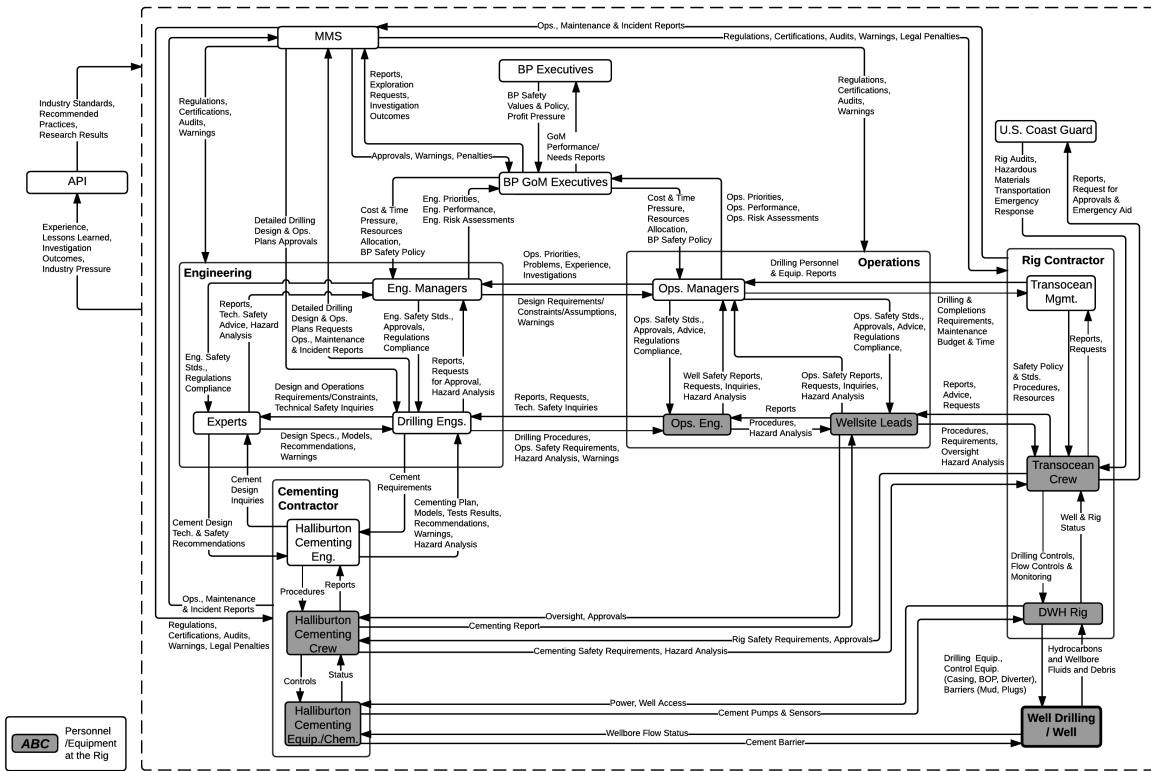
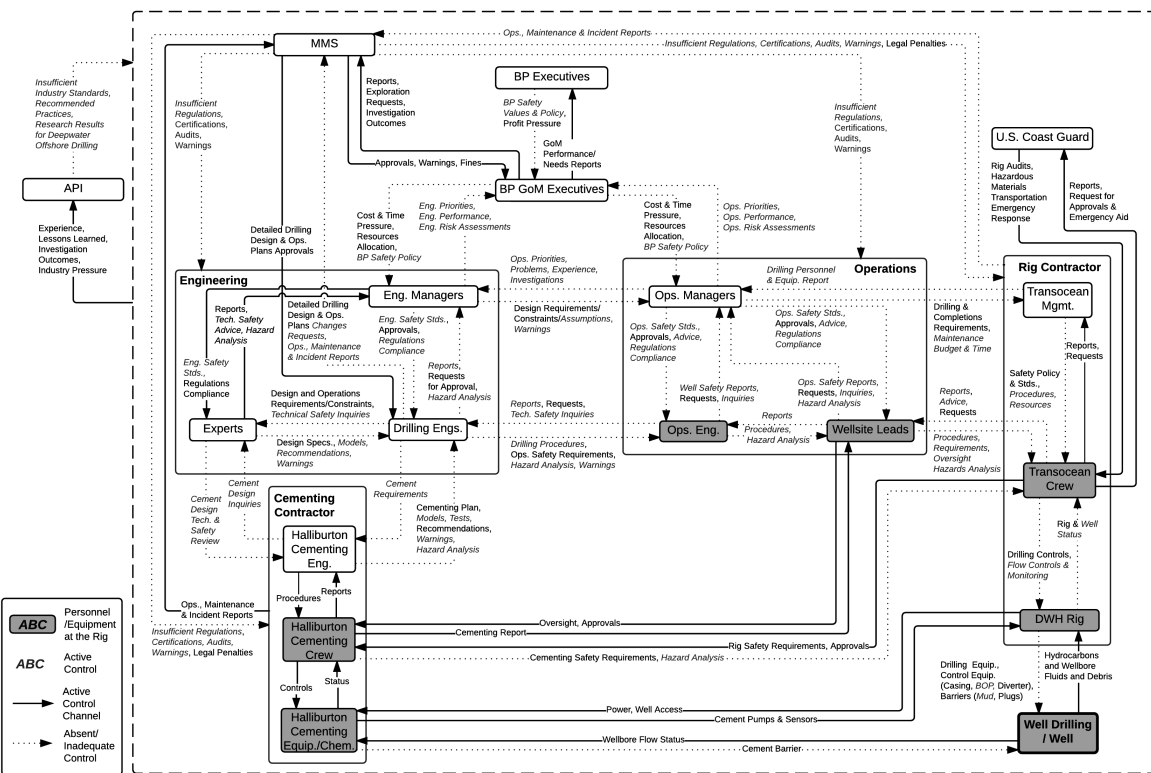
Figure 19. Theoretical safety control structure of the Macondo well integrity (Top). Existing safety control structure the Macondo well integrity at the time of the blowout (Bottom).

Reorganization. BP’s Macondo team underwent a considerable change a month before the blowout as part of the reorganization of the entire Exploration Business Unit (BPX). Figure 20 shows the structure up until March and Figure 21 shows the new structure established in early April. The impact of the change highly affected the decision scheme of the team. As can be seen in the diagrams the leader conciliating the engineering and the operations of the well was completely removed from the team.

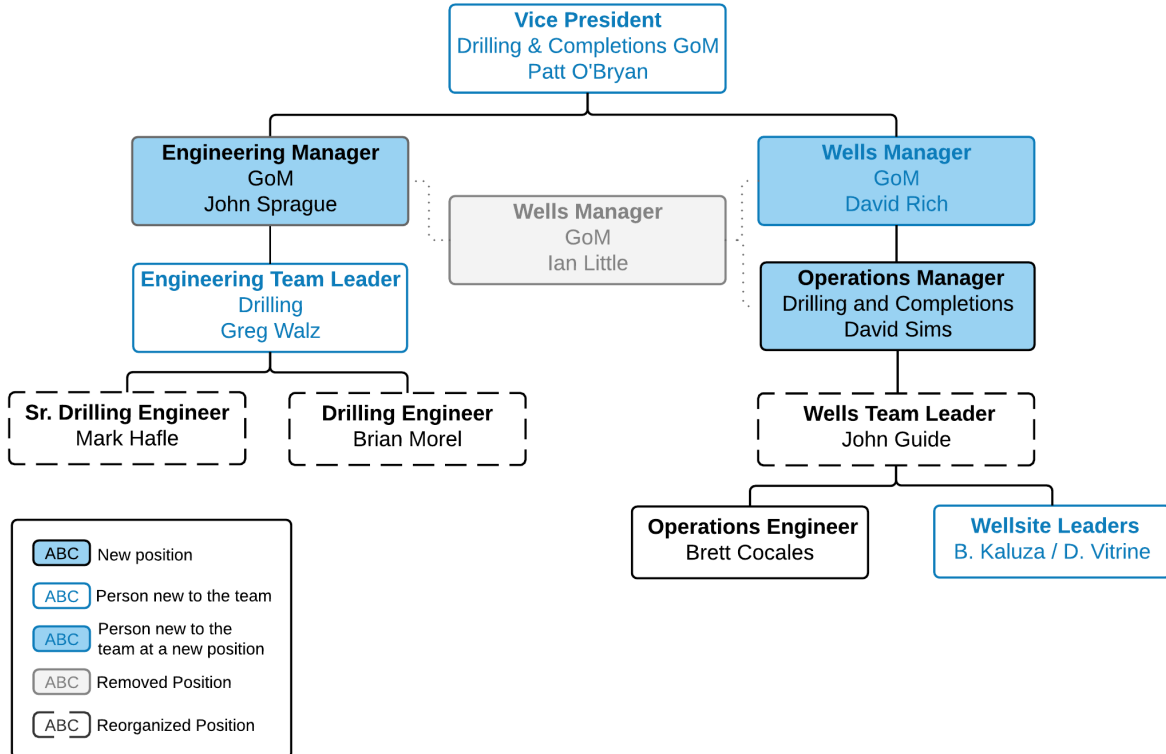
Figure 21. New Organization of the Macondo Drilling Team.

After a careful study of this role, it is not clear who took over several of his safety-related responsibilities, including:
