Lessons Learned from Two Years of On-Orbit Global Positioning System Experience on International Space Station

Susan F. Gomez , *NASA Johnson Space Center*
Michael L. Lammers , *NASA Johnson Space Center*

ABSTRACT

The International Space Station GPS receiver was activated in April 2002. Since that time, numerous software bugs surfaced that had to be worked around. Eventually, enough bugs surfaced that the three pieces of code included in the GPS unit have been upgraded.

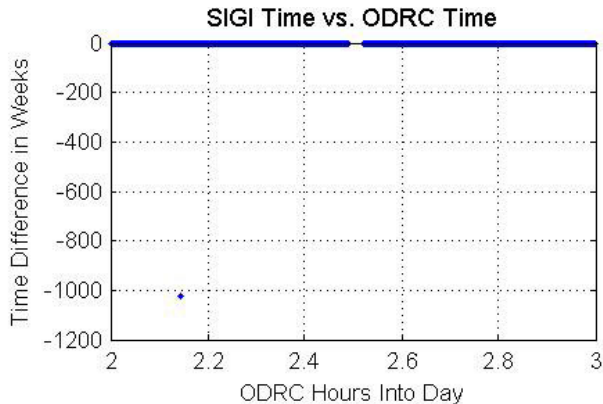
In another case, the SIGI's time was observed to jump by entire GPS epochs. This was traced to code in the SIGI that was attempting to use GPS leap seconds to determine how many GPS rollovers had occurred.

Figure 2 shows some of the time data from the SIGI on the ISS. SIGI's time is compared to the time stamp placed on the telemetered data by the Orbital Data Reduction Complex (ODRC). Notice the jump of 1024 weeks near the beginning of the plot.

Figure 2 – SIGI Time Compared to ODRC Time

Notice the time output at 2002_142:02:08:44.296 in which the SIGI time jumps back in time 1024 weeks, but recovers on the subsequent output.

These time problems were all traced back to coding deficiencies in the HI SP. The problems with the code were corrected and the new HI SP code has been tested in all of the scenarios that caused the problems noted above. Unfortunately, one new problem has been uncovered that will occur when there are 15 leap seconds and will manifest itself as time jumping entire GPS epochs. This problem will have to be corrected prior to the leap seconds reaching 15.

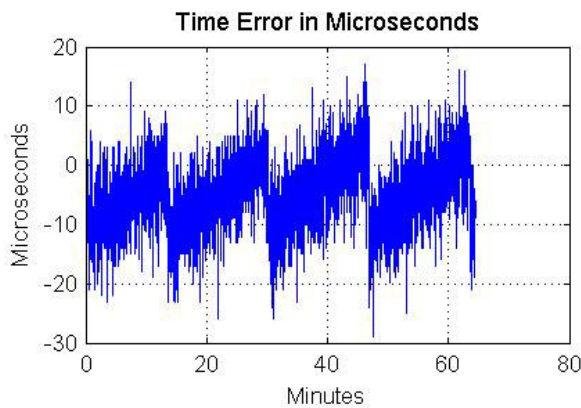
Figure 3 – Time Error in Microseconds When Tracking at Least 4 Satellites

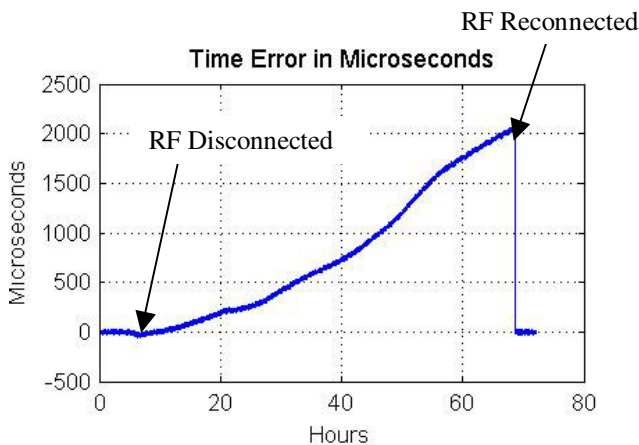
propagates at the rate of the error in the last output drift rate. Previously, HI propagated time using their clock, which wasn't nearly as accurate as the GPS clock. Under the new design, the time drifts at a lower rate than the drift rate of the GPS oscillator since that last measured drift rate is compensated for. Figures 3 and 4 show the time error for the new SIGI code compared to a True Time GPS card. Figure 3 is for a time period when the SIGI is tracking at least 4 satellites, and Figure 4 includes a period when the Radio Frequency (RF) port was disconnected so that SIGI was not tracking satellites.

Figure 4 – Time Error in Microseconds: SIGI RF Port Disconnected for Weekend

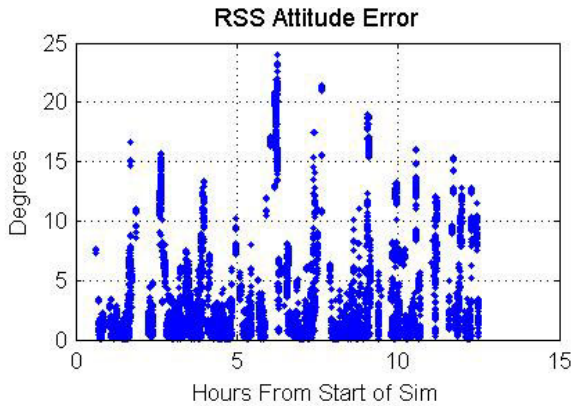
Figure 5 – Attitude Error in Degrees for Orbit Simulation with ISS Multipath Environment – New SIGI Firmware

The new SIGI firmware is computing an attitude with no initial attitude estimate. The original firmware has an initial estimate for the roll and pitch of the ISS. The new firmware has more coverage and better standard deviation statistics: 26 degrees root mean square for the original method and 4 degree root mean square for the new firmware.

Since the integer resolution scheme mentioned above was not well suited for ISS, the attitude code was reformulated using a new integer resolution method as part of the re-code effort. This new method simply accumulates measurements over a user-settable interval and performs a batch solution for the attitude and the integers. The new method assumes that the ISS is in either an inertial hold or a Local Vertical Local Horizontal Hold (LVLH), which are the only types of attitudes the ISS flies in. See reference 8 for more information on the new integer resolution algorithm.

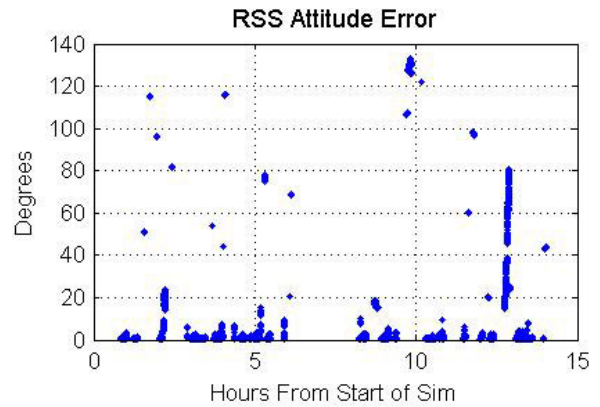
Additionally, the integer resolution scheme is a search method originally designed for use in aircraft. The method used is described in [Ref 7]. This method requires an initial attitude estimate, which implies operational constraints. For many of the ISS maneuvers, it is not worth the time required to re-initialize the GPS receiver with an attitude estimate. Also, since the attitude input has to be an East, North, Up attitude, when the ISS is in an inertial hold, the attitude update would have to be constantly updated. Instead, for certain maneuvers, it is accepted that the GPS will not be outputting attitude solutions. For the inertial attitudes, the attitude estimate is input as the attitude of the ISS at orbit noon, where there is the best GPS coverage. However, for the rest of the orbit, any attitudes that are output are all incorrect since the attitude estimate is incorrect. This search method requires that all interrupts be stopped during the search time, meaning that no position or velocity information is output during these times.

Figure 6 - Attitude Error in Degrees for Orbit Simulation with ISS Multipath Environment – Original SIGI Firmware

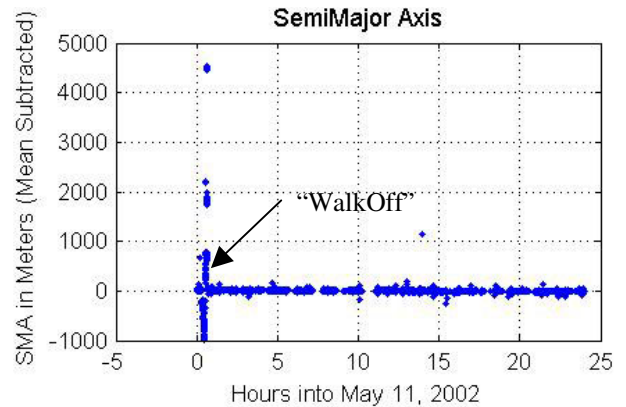
There were also problems encountered with the navigation solution. These have been traced to various root causes, but the symptom was very similar in each case. The symptom is that the position and velocity solutions are incorrect, and slowly ‘walk off.’ The ISS error checking tends to accept the ‘walk offs’ as valid since the GPS receiver output slowly walked off from the correct answer, rather than just outputting a single anomalous solution. Figure 7 shows a sample of such a walk off in the semimajor axis. Semimajor axis combines the position and velocity outputs into a single number. For ISS, the semimajor axis, when compensated for J2, is a fairly constant number.

Figure 7 – Semimajor Axis For May 11, 2002

The walk-offs were tracked to several sources. One source was the receiver tracking satellites thru the Earth's atmosphere, which caused severe distortion of the pseudorange signal. Another factor was the health message which was output in a separate message from the navigation solution, but was occasionally being incorrectly associated with the previous navigation solution rather than the current navigation solution.

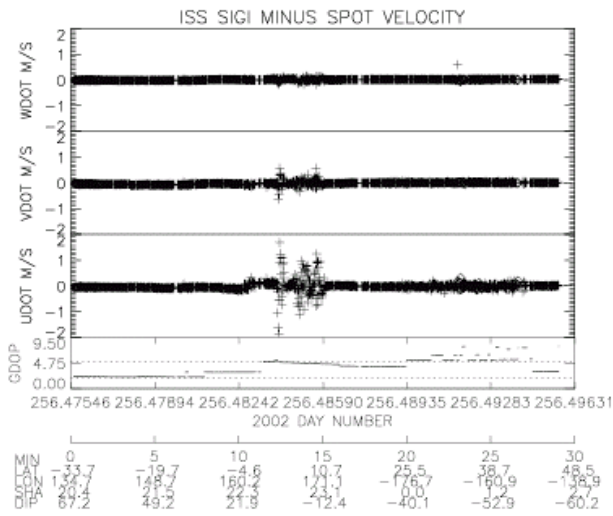
Velocity noise has also been observed in ISS GPS measurements. Reference 9 contains an analysis of both ISS and Shuttle measurements that show this phenomenon. It appears to be related to high ionospheric activity. Figure 8 shows the SIGI's velocity noise as compared to a ground filter (SPOT).

Figure 8 – SIGI Velocity Noise as Compared to Ground Filter

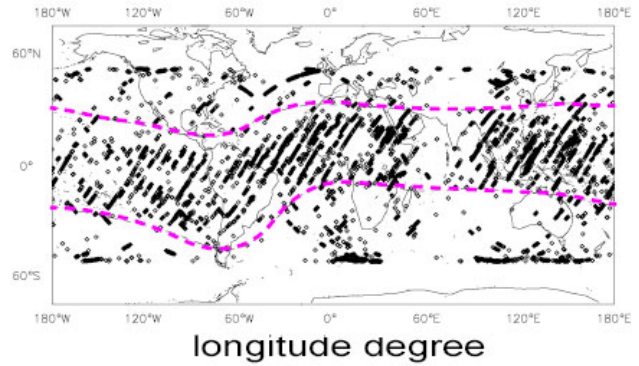
2002 Day 256 through 266

Figure 9 shows the latitude and longitude of the GPS solution when the velocity was output with an error that exceeded 0.5 meters/second. These noisy outputs appeared to be clustered in similar patterns as described in [Ref 12].

Figure 9 – Latitude And Longitude for Noisy SIGI Velocity Output

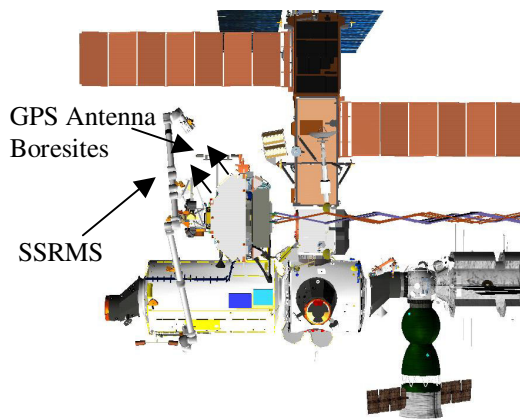
Figure 11 - SSRMS Parked Over GPS Antenna Array.

When the SSRMS is parked over the array, interference results in lower attitude coverage from SIGI. This is primarily an impact when ISS is flying inertial attitudes, since SIGI attitude coverage in these attitudes is already low. In some cases, the coverage has been reduced enough that the attitude filters within the US GNC flight software could not remain reliably converged using the attitude data from SIGI.

Instead, flight controllers work around the problem by reconfiguring the software to utilize attitude data from the Russian Segment GNC system, which is available to the US GNC flight software as a backup to GPS.
