Report on the Loss of the Mars Polar Lander and Deep Space 2 Missions

JPL Special Review Board

22 March 2000

JPL D-18709

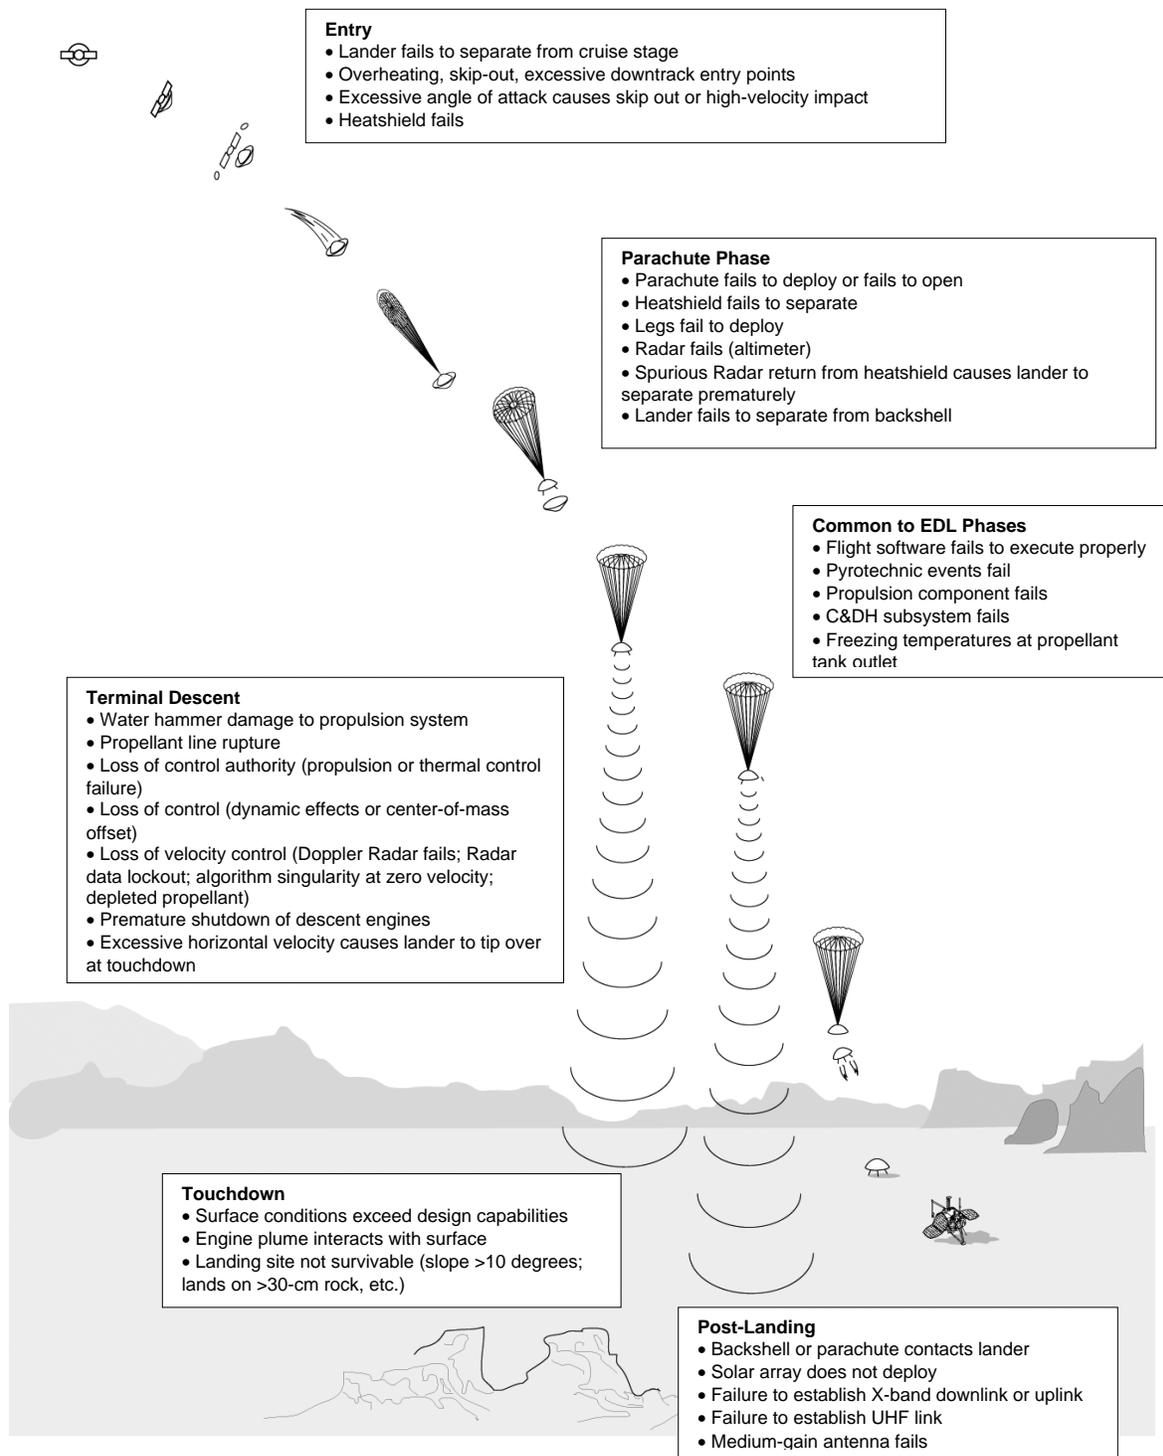
Figure 6-1. MPL Entry, Descent, and Landing (EDL) Sequence with Potential Failure Modes

Figure 6-1 depicts the MPL EDL sequence and shows potential failure modes.
