7.4.6 Coaxial Transfer Switch Fails

FAILURE MODE DESCRIPTION

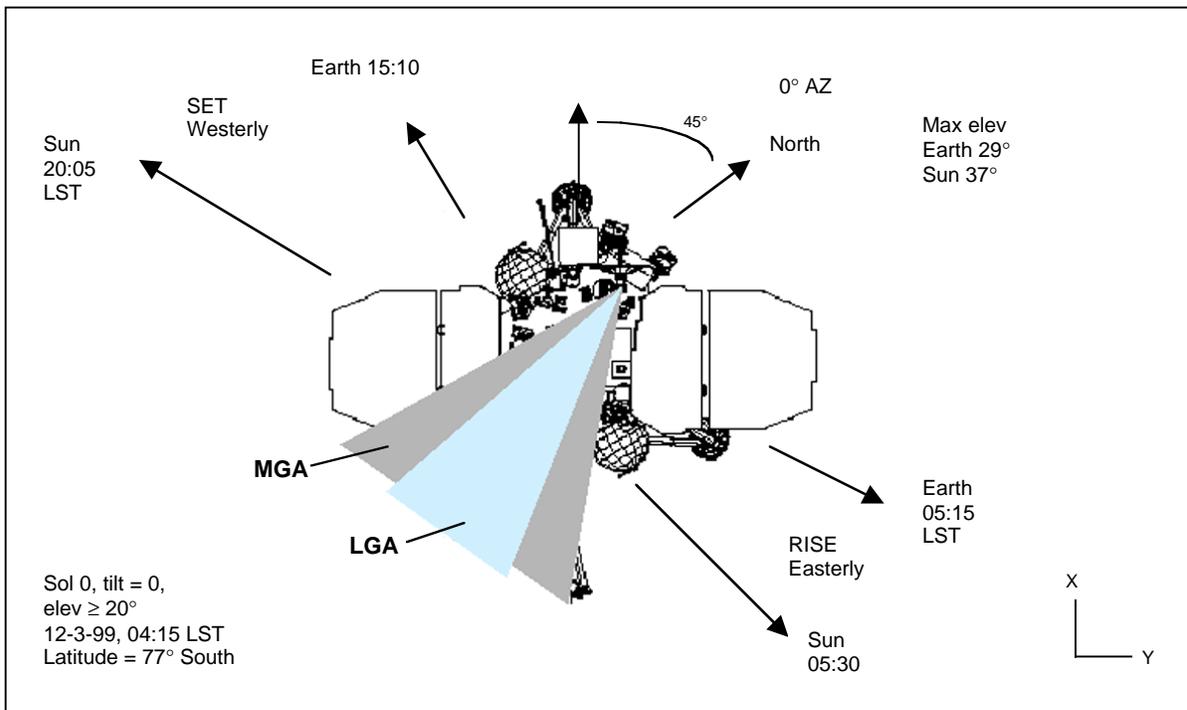
Figure 7-6. Command-Blind Zones in Azimuth for MGA (125 bps) and LGA (7.8125 bps)

The LGA is fixed and pointed at the approximate center of the nominal Earth azimuth range. In elevation, the LGA boresight is pointed approximately 43 degrees above the lander deck and the nominal horizon line. The mean Earth elevation angle is approximately 17 degrees above the horizon. In the worst-case azimuth orientation (180-degree error), the mean Earth would be 120 degrees off boresight. At 7.8125 bps, an uplink can be received by the spacecraft at up to 135 degrees off boresight. So there is at least a chance of getting an uplink into the spacecraft in the worst-case azimuth orientation. However, since Earth is frequently at lower than mean elevation, it is probably more realistic to consider a region of ± 16 degrees (elevation error) around the worst-case landing azimuth error to be a “command blind” zone.

Only if the onboard sequence is cancelled (stopping the nominal UHF pass) *and* the landing azimuth error puts the lander in the “command blind” zone (see above) would the lander be in a configuration that would not support either an X-band or UHF link. UHF is not especially azimuth sensitive, as long as there is a reasonable elevation angle. The peak elevation angles for the Sequence C UHF passes were 82.8 degrees on DOY 341, 56.5 degrees on DOY 342, and 86.6 degrees on DOY 343.

There is a landed orientation in which an X-band uplink cannot be established through the MGA or the LGA. Precluding the establishment of an uplink path requires either a malfunction of the gyro compassing function or a severe rotation of the lander at touchdown.

Review the antenna coverage and determine under what possible landed orientations a telecommunications link can be maintained. Maximize the configuration to obtain initial link acquisition and engineering health and safety data return.

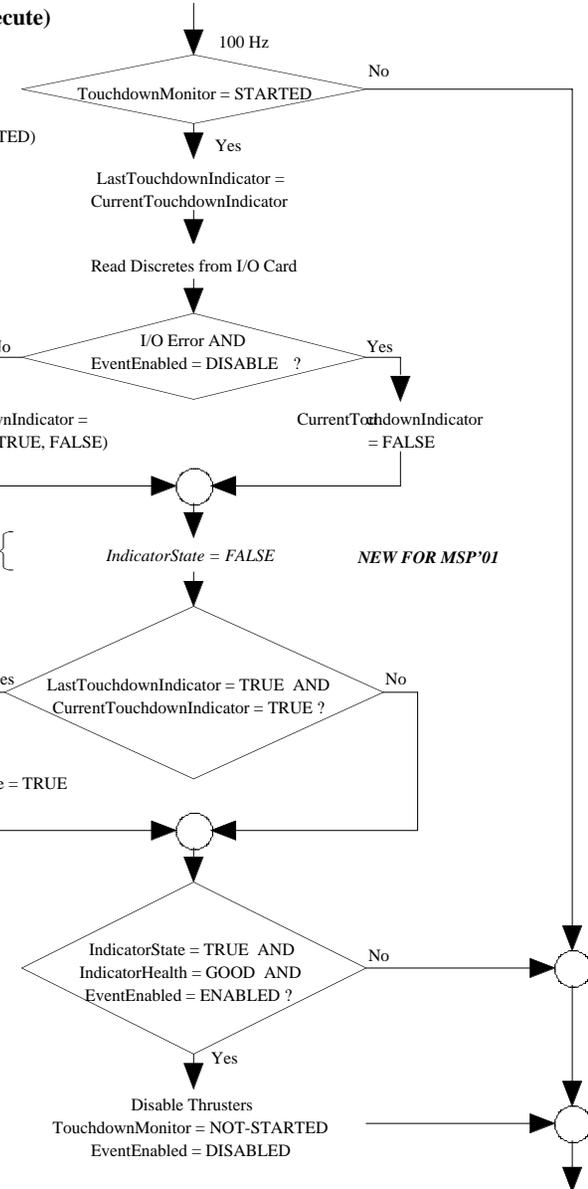
Figure 7-8. Touchdown Monitor Functional Flow Diagram

MISSING FROM MPL
