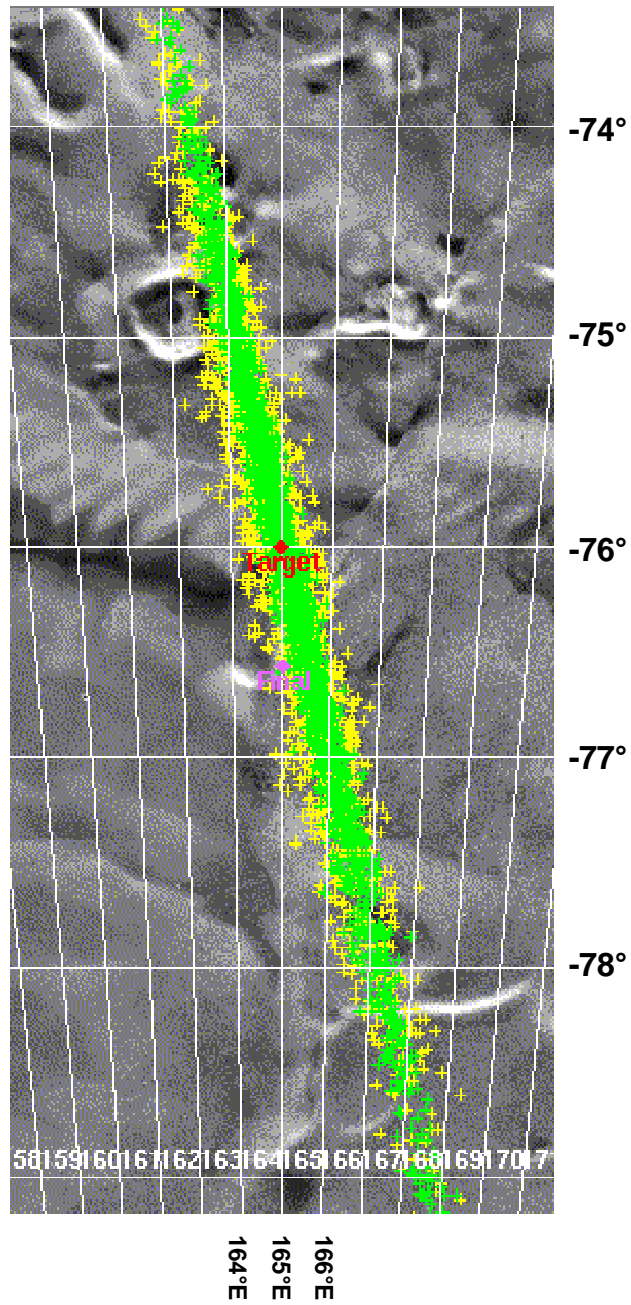
Figure 7-3. Required Maneuver-Execution Errors, LaRC 6DOF 3/3/00 (Yellow [Light]) and TCM-4 Planning Ellipse, LaRC 3DOF 11/23/99 (Green [Dark])

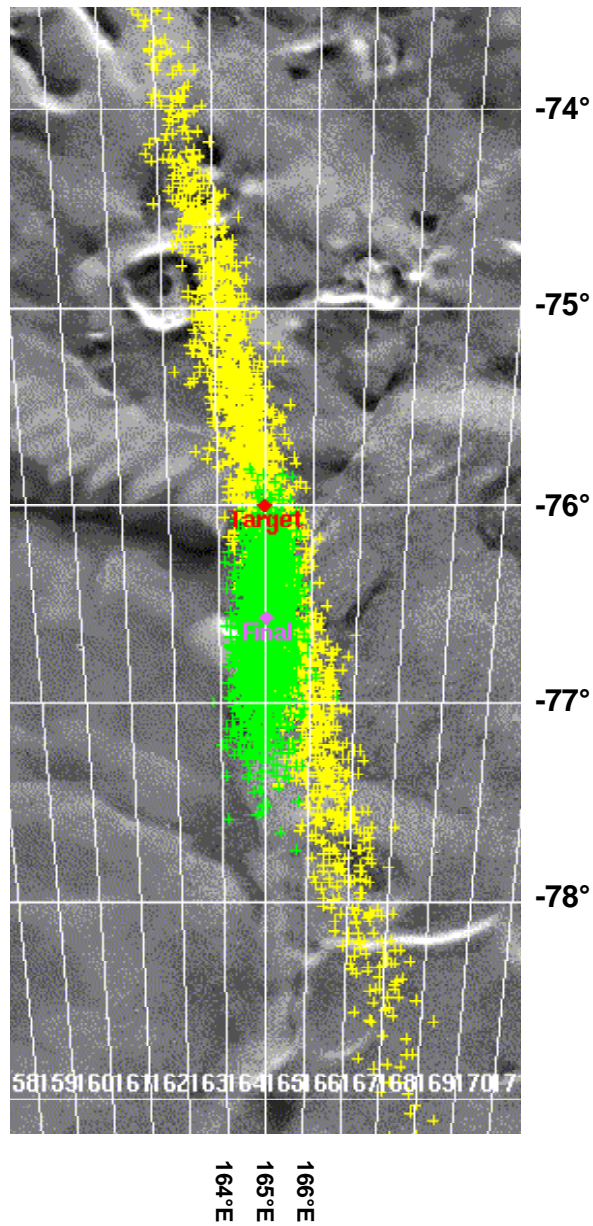
**Figure 7-4. Required Maneuver-Execution Errors, LaRC 6DOF 3/3/00 (Yellow [Light])  
and Final Estimated Ellipse, LARC 6DOF 3/3/00 (Green [Dark])**
