System Theoretic Safety Analysis of the Sewol-Ho Ferry
Accident in South Korea

by
Yisug Kwon

Submitted to the System Design and Management Program in
Partial Fulfillment of the Requirements for the Degree of

Massachusetts Institute of Technology

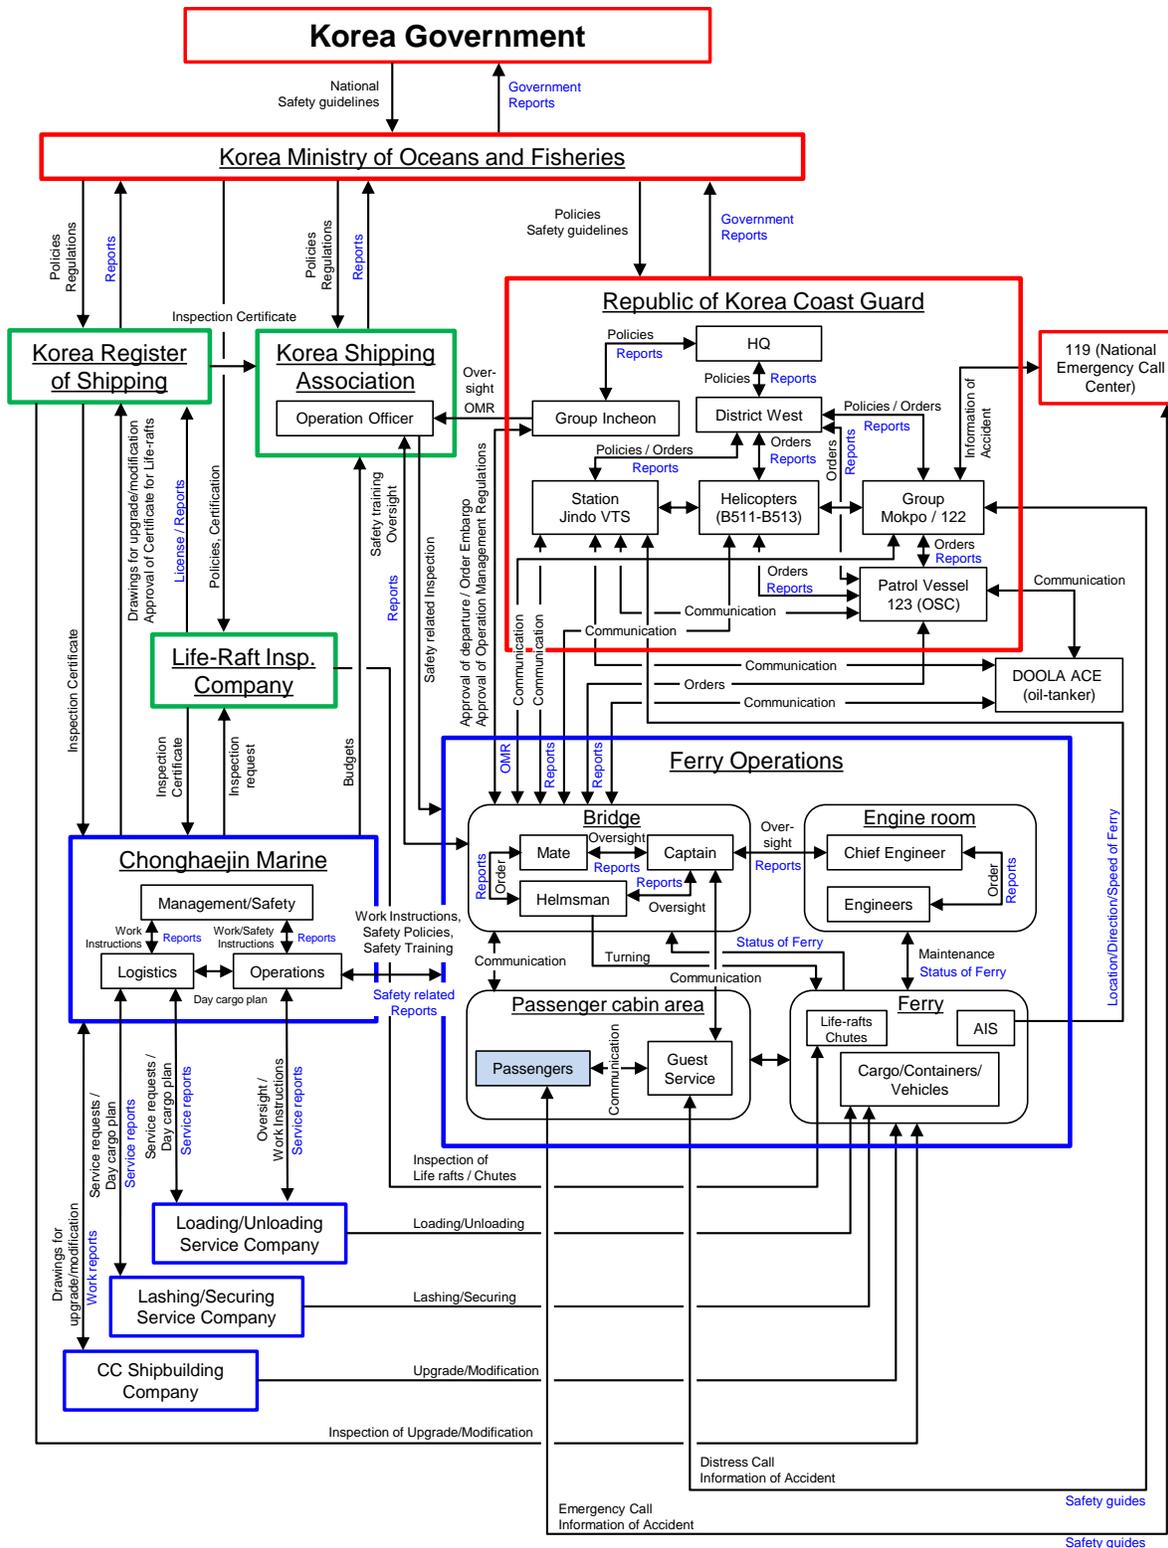
Figure 3 System Safety Control Structure of generalized Maritime Transportation System

A high level system safety control structure is created to capture the primary controllers, the control actions and feedback. As shown in Fig. 3, the system safety control structure is highly simplified and idealized in order to capture a generalized Maritime Transportation System.

Each component in the high level control diagram shown in Fig. 3 has the responsibilities in enforcing the necessary system level safety constraints, “The ferry must not capsize” and “All people must be rescued when the ferry is in distress.” The arrows connecting the elements indicate control actions, controlled variables, measured variables, and feedback. The bi-directional arrows indicate control actions in black letters to down direction and feedback in blue letters to up direction.

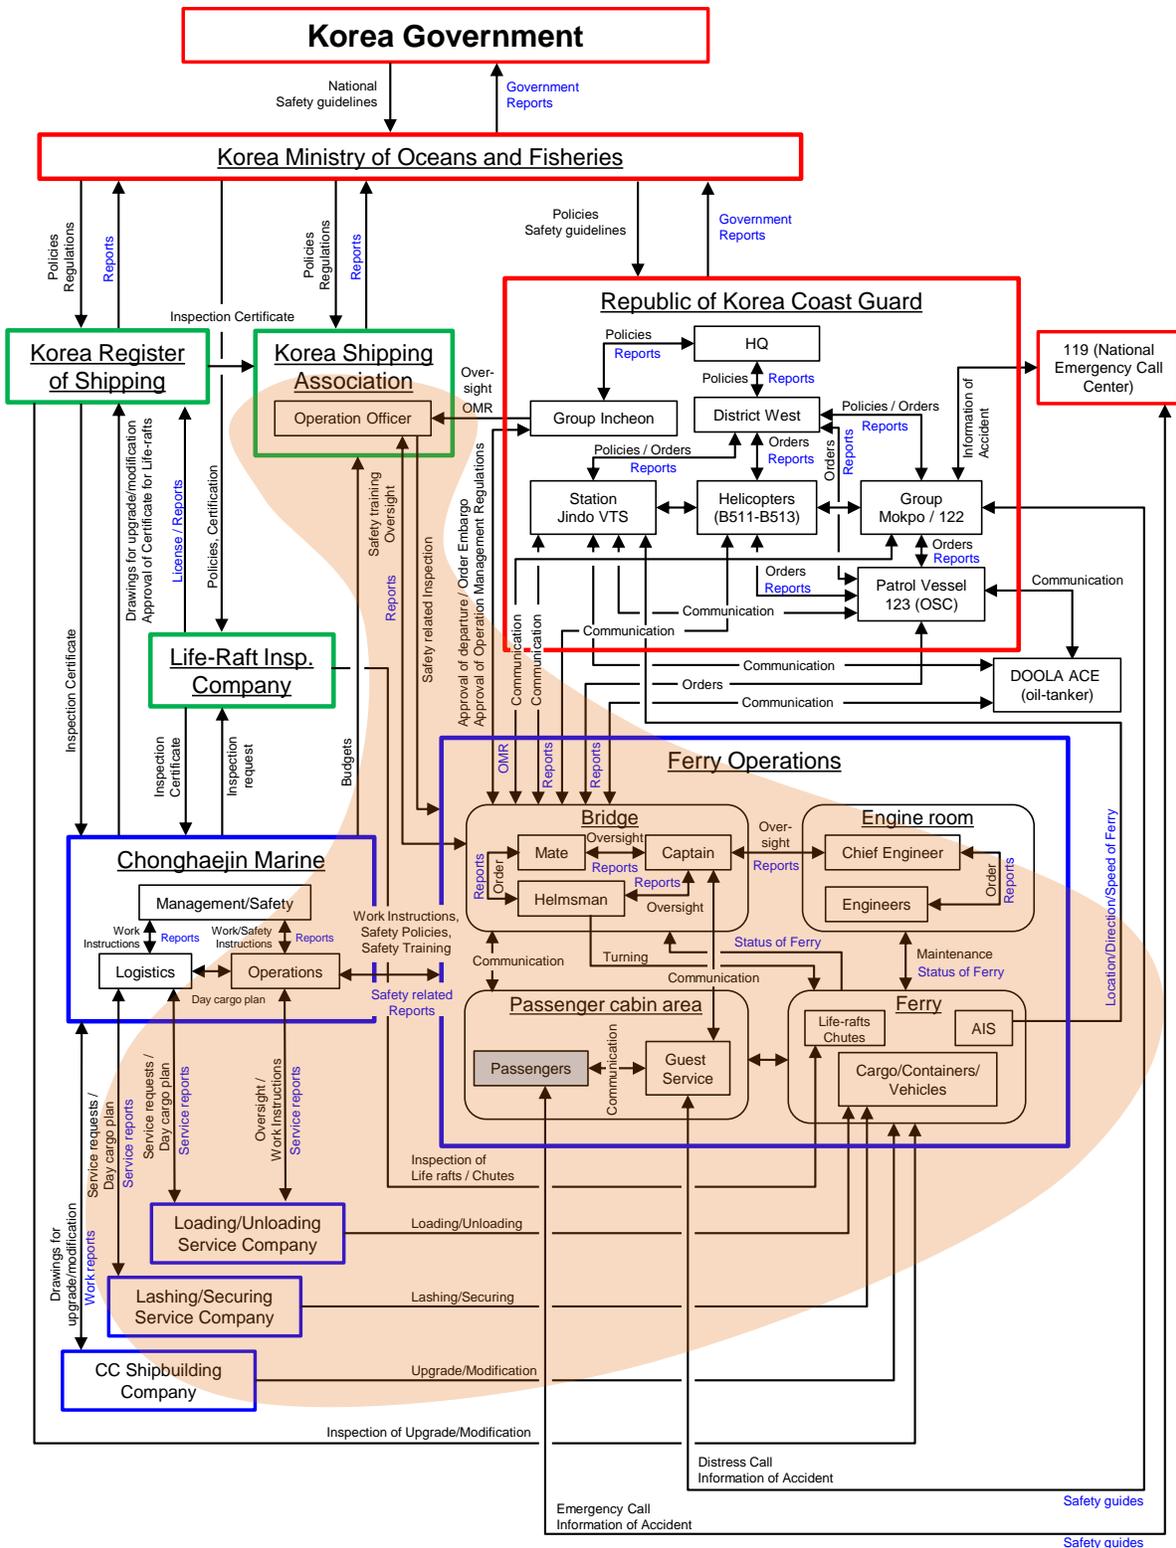
Figure 4 System Boundary for Process 1 of “Safe operations of the ferry” (pink)

As indicated in the high level safety control structure shown in Fig. 4 and 5, the CAST analysis has been carried out separately with each system boundary defined for the two processes to include the following:

- The Sewol-Ho Operations, Chonghaejin Marine Company, Korea Shipping Association, and Loading and Lashing Service Companies acting upon the ferry as the controlled process as shown in Fig. 4 (pink area).
- The Sewol-Ho Operations, Chonghaejin Marine Company, and ROK Coast Guard acting upon the passengers as the controlled process as shown in Fig. 5 (green area).
