A System Theoretic Safety Analysis of U.S. Coast Guard Aviation Mishap involving CG-6505

Submitted to the System Design and Management Program
in Partial Fulfillment of the Requirements for the Degree of

Master of Science in Engineering and Management
at the
Massachusetts Institute of Technology

May 2012

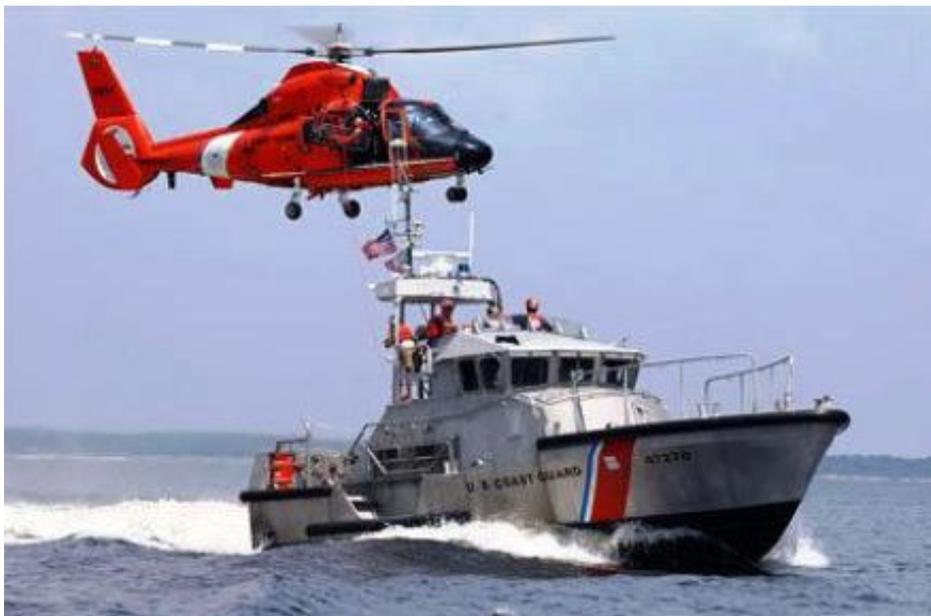
Figure 3.2 - CG HH-65 Helicopter Conducting Hoisting Operations with a CG 47-foot Small Boat
