Lessons Learned from Two Years of On-Orbit Global Positioning System Experience on International Space Station

Susan F. Gomez , *NASA Johnson Space Center*
Michael L. Lammers , *NASA Johnson Space Center*

ABSTRACT

The International Space Station GPS receiver was activated in April 2002. Since that time, numerous software bugs surfaced that had to be worked around. Eventually, enough bugs surfaced that the three pieces of code included in the GPS unit have been upgraded.

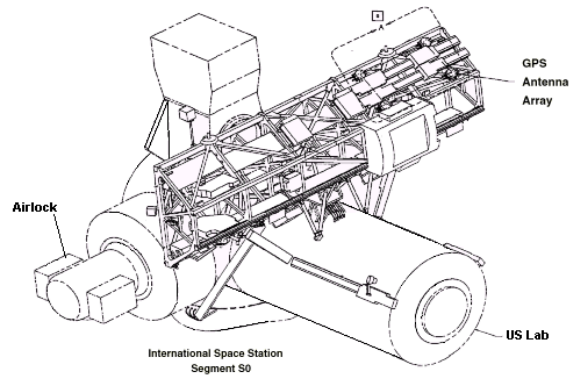
Figure 10 - GPS Antenna Array.

The ISS GPS antenna array consists of four antennas in a 3 meter by 1.5 meter rectangle on the S0 element of the ISS main truss. The array center is slightly to the port side (4 meters) of the vehicle centerline, as shown in Figure 10.
